Project acronym:	GeoSmart		
Project title:	Technologies for geothermal to enhance competitiveness in smart and flexible operation		
Activity:	LC-SC3-RES-12-2018		
Call:	H2020-LC-SC3-2018-RES-SingleStage		
Funding Scheme:	IA	Grant Agreement No:	818576
WP2	Development of Thermal Energy Storage System

D2.7 Final material choices documented for demo sites

The deliverable is an update of D2.1Correct material choices documented for demo sites and reports on the evaluation of performance of selected carbon and stainless steel grades in the phase change material (PCM) environment.

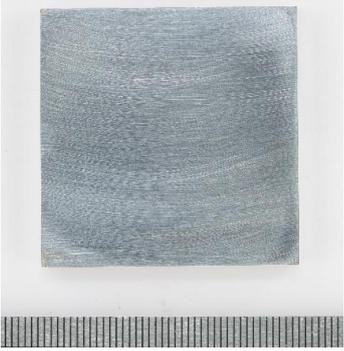
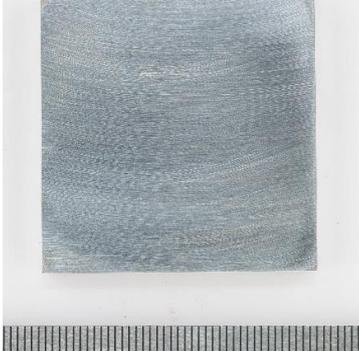
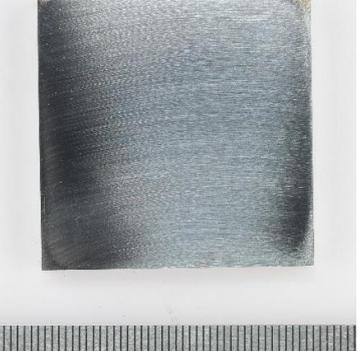
Visual assessment of the samples prior to testing showed a bright metallic finish (Figure 3). Following testing the surface had turned a slight pink colour, however, no obvious surface deposits were observed. Following cleaning the samples were returned to their metallic finish with some black staining on the surface.

Figure 3 Photographs showing samples composed of SA516 prepared to a 600 grit finish before testing (pre-test), after testing (post-test) and post-cleaning.

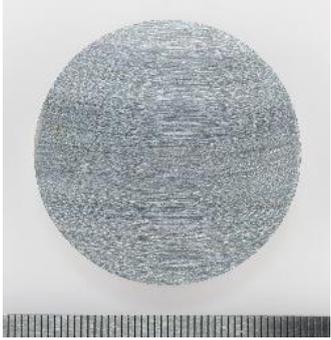
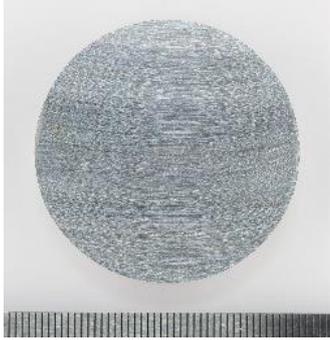
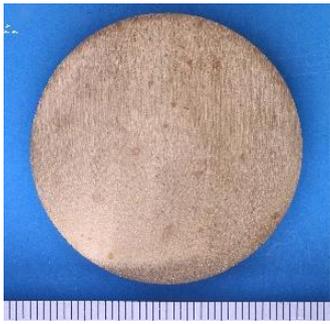
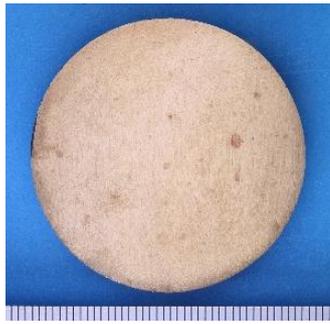
Visual assessment of the samples was consistent with the as-received samples in all conditions, though the post-cleaning samples appeared less effected by the cleaning process (Figure 7).

Figure 7 Photographs showing samples composed of SA105 prepared to a 600 grit finish before testing, after testing and post-cleaning.

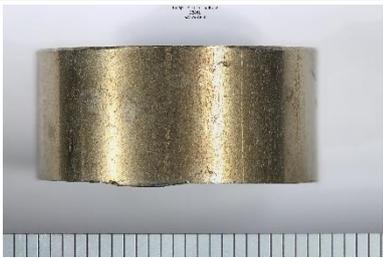
Prior to testing the samples had a grey metallic finish with a number of brown spots across the surface (Figure 9). Following corrosion testing, the sample has a gold colour but no surface deposits were observed. Following cleaning the original grey metallic colour was observed.

Figure 9 Photographs showing samples composed of SA179 in the as-received condition before testing, after testing and post-cleaning.

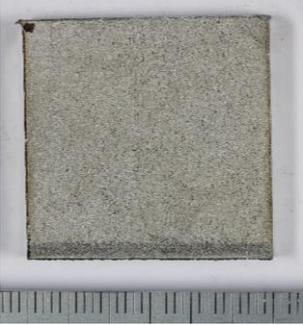
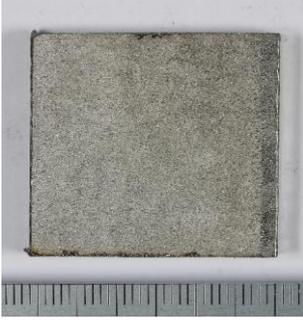
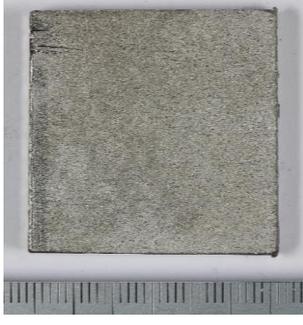
The samples prior to testing had a dull grey finish with a rough surface texture. The visual appearance of the samples appeared unchanged following testing or cleaning (Figure 13).

Figure 13 Photographs showing samples composed of 304L in the as-received condition before testing, after testing and post-cleaning.

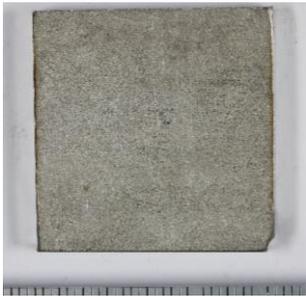
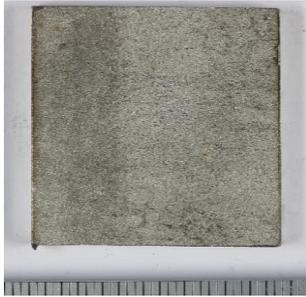
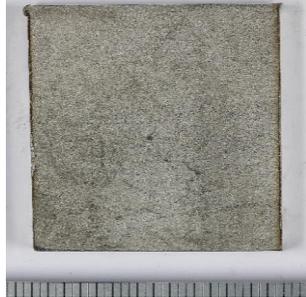
The samples prior to testing had a dull grey finish with a rough surface texture (Figure 17). The visual appearance of the samples appeared largely unchanged following testing or cleaning.

Figure 17 Photographs showing samples composed of 316L in the as-received condition before testing, after testing and post-cleaning.
